## IRRIGATION SYSTEM DAMAGE DURING A HARD FREEZE

*Submitted by Gary Boswell*

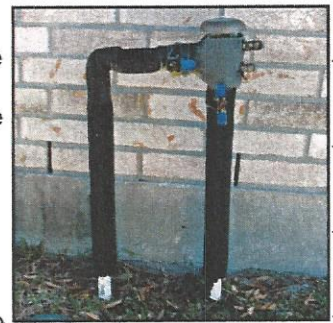
During the hard freeze in early January 2010, many homeowners experienced breaks in their irrigation systems. Most, if not all, of these breaks occurred when the vacuum breaker (the small domed apparatus on the horizontal section) burst from water freezing in this apparatus, being the weak link of the backflow system. This series of valves and vacuum breaker are all part of the backflow system to prevent irrigation water, considered non-potable, from back flowing and contaminating our drinking water.

Close the valve in the vertical line of the backflow system (the vertical line is assumed to be the source water line) – turn the valve until it "snaps" closed and the handle is completely perpendicular to the pipe run.

Remove the two black rubber threaded plugs and turn the slotted screws on the side by  $\frac{1}{4}$  turn to bleed the vacuum breaker – there will be an initial spurt of water followed by drips – leave the screws in this position so water can bleed out as it freezes.

Be prepared to insulate your backflow system when a freeze is forecast for the area. If the temperature is anticipated to remain below freezing (32°F), especially several degrees below freezing ( $\leq 28^\circ\text{F}$ ), for several hours, then the vacuum breaker should be drained before the insulation is put into place. Follow these simple steps to drain the vacuum breaker and protect the backflow system:

Use an insulation wrap or cover, a large towel, old quilt, etc. to provide a 4" thick insulation wrap around the system – duct tape can be used to keep the insulation from blowing off.
